FINAL REPORT
RICHARDSON FLATS TAILINGS
SUMMIT COUNTY, UTAH
TDD #T08-9204-015 and #T08-9210-050
PAN EUT0039SBA and EUT0039SDA

U.S. Environmental Protection Agency
Region VIII
Waste Management Division
Mike Zimmerman, On-Scene Coordinator

Scott Keen
Ecology and Environment, Inc.
Technical Assistance Team

DATE SUBMITTED: February 19, 1993

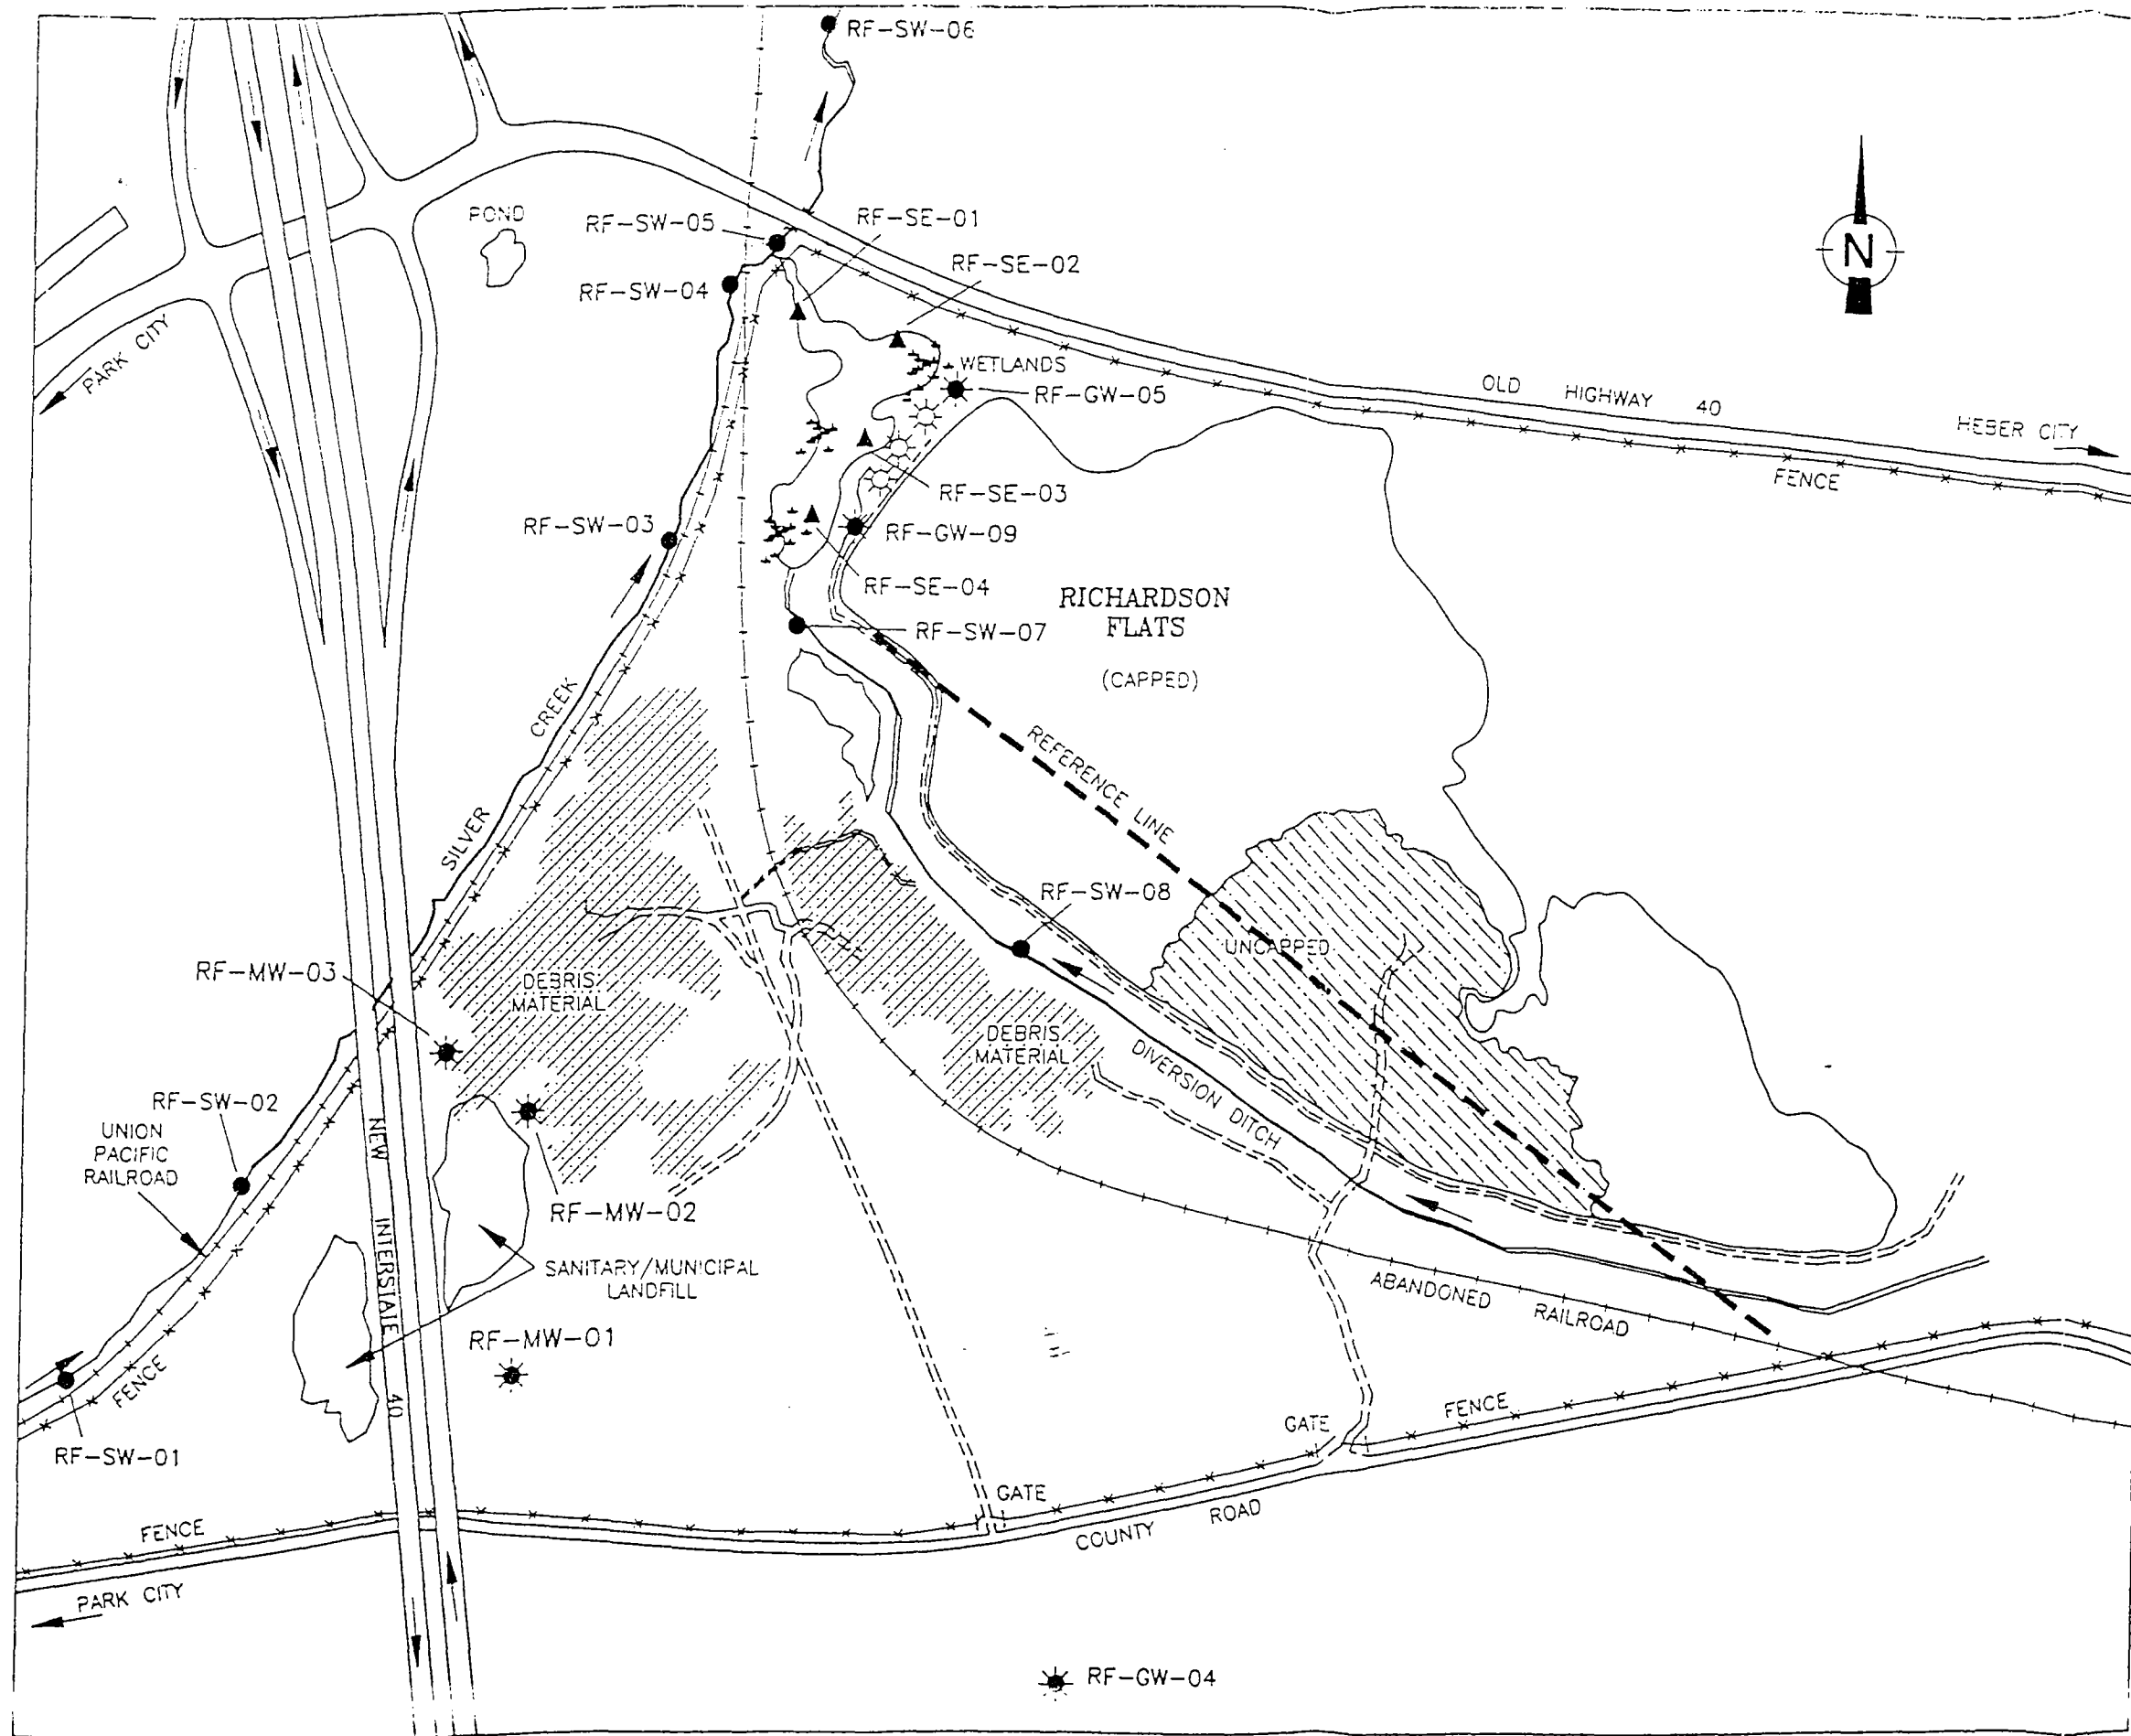
TECHNICAL ASSISTANCE TEAM FOR EMERGENCY RESPONSE, REMOVAL AND PREVENTION EPA CONTRACT 68-WO-0037	
TITLE: RICHARDSON FLATS Park City, Utah SAMPLE LOCATION MAP T.O.D. T08-9304-015	
ecology & environment, inc. DENVER, COLORADO	FIG. 1
Date: 08/92 Drawn by: RSM Scale:

Surface water samples collected for assessment of the tailings area are shown on Figure 1. These eight sample numbers are RF-SW-01 through RF-SW-08. Inorganic analytical results for surface water samples are presented in Table 3. Within Silver Creek samples RF-SW-01 through RF-SW-04 are considered upgradient of the tailings area and samples RF-SW-05 and RF-SW-06 are downgradient. In comparing upgradient sample results with downgradient sample results very few significant differences are noted. Lead increases by a factor of 5.7 in sample RF-SW-05 when compared to the average lead concentration of the four upgradient samples. In sample RF-SW-06 arsenic increases by a factor of 2.1 and silver increases by a factor of 4.2 when compared to the average concentration of the four upgradient samples.

Figure 1 shows a "wetlands" area between the base of the tailings dam and Silver Creek. Within this area four sediment samples were collected. Results of inorganic analyses of these samples is presented in Table 7 along with the normal ranges of elemental concentrations in soils of the western United States.
